Beatrice, Nebraska

Blight & Substandard Determination Study &
General Redevelopment Plan.
Redevelopment Area #1-Revised.

February, 2017

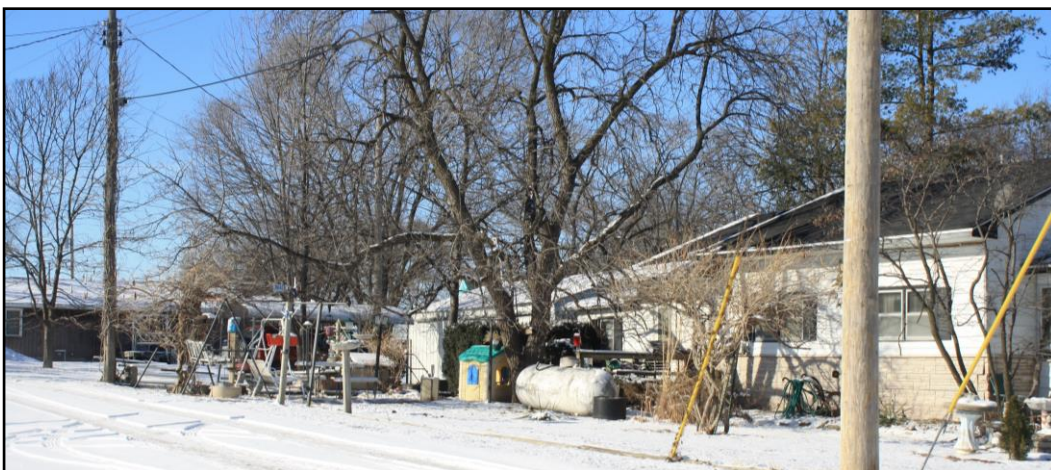
Parcels containing minor or major debris were observed in **Area #1**. A total of 20 parcels, or 7 percent of the total 273 individual parcels contained minor debris, while an additional 10 parcels, or 4 percent contained major debris. Excessive debris can contribute to an environment that harbors vermin, pests and potential disease in close proximity to human habitation.

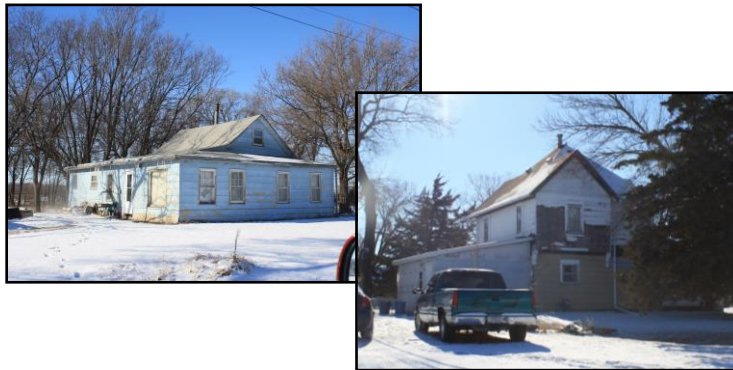
Field research identified **77 parcels, or 28 percent of the total 273 individual parcels in the Area as being in “fair” condition and an additional 38 parcels, or 14 percent being in “poor” condition**. These conditions combine for **42 percent** of the total parcels having “fair” to “poor” overall site conditions. This determination included the evaluation of the general condition of structures, site improvements and adjacent right-of-way conditions.

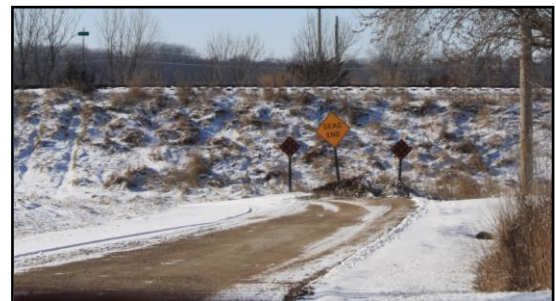
A total of 86 parcels, or 32 percent of the total 273 individual parcels are located on streets in “fair” to “poor” condition. Several streets in the Glenover Addition have gravel surfacing and are in need of asphalt or concrete paving. Portions of frontage roads associated with the Highway 77 Corridor (6th Street) are inadequately marked and mesh together with parking lots associated with various commercial and industrial entities.

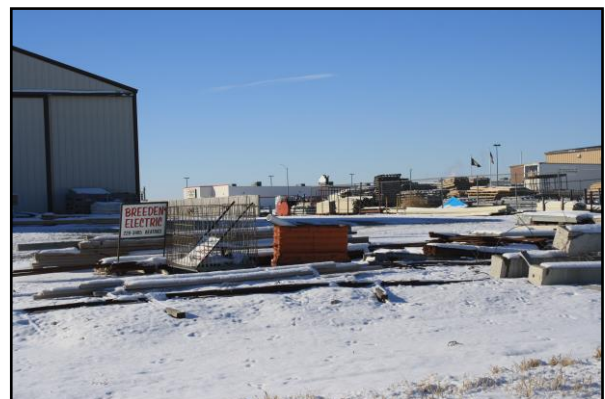
Parcels containing minor or major debris were observed in **Area #1.** A total of 20 parcels, or 7 percent of the total 273 individual parcels contained minor debris, while an additional 10 parcels, or 4 percent contained major debris. Excessive debris can contribute to an environment that harbors vermin, pests and potential disease in close proximity to human habitation.

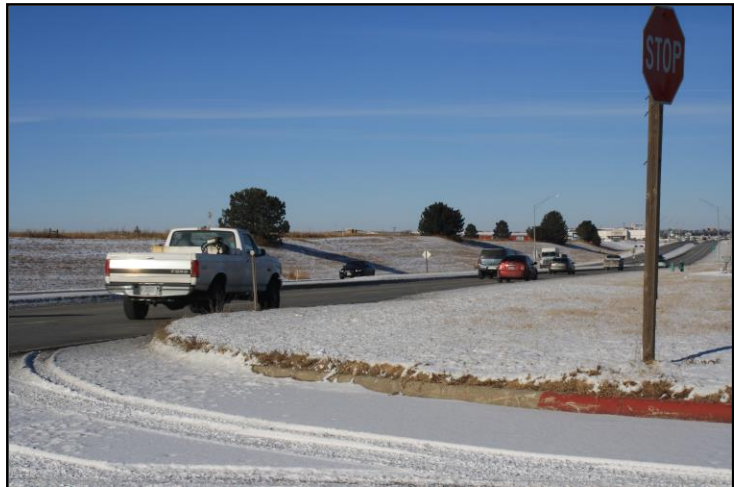
Functional and economic obsolescence is apparent in parcels originally platted too small for modern development. Several parcels in **revised Redevelopment Area #1** are also considered "undevelopable" due to natural or topographic issues. This includes a large portion of undeveloped land between the Beatrice Municipal Airport and the Highway 77 Corridor in which a large grass berm prohibits development. Additionally, a parcel of land along Industrial Row is located within the approach zone of the Municipal Airport runway and, thus, is undevelopable.

Original lots in the Glenover Addition were platted at roughly 50 x 140 feet; too small to support today's development requirements. Lots of record, as per the Gage County Assessor office consist of multiple, originally platted lots for their buildings, thus the lot of record does not match the originally platted lot. Several parcels would have to be acquired for new development.
