Americans with Disabilities Act Review of Public Facilities

City of Beatrice

10/6/2025

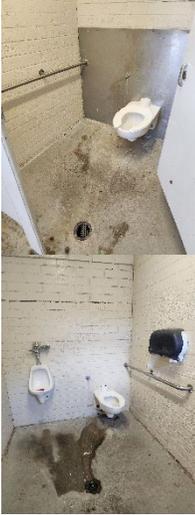
\$500	<p>Men's and Women's Park Restrooms: Grab bars are non-compliant.</p> <p>36" Grab bar on back wall is missing.</p> <p>Toilet paper dispenser intrudes clear space on sidewall grab bar in men's (need at least 12" of clear space above grab bars).</p>	3	<p>Add a grab bar to the back wall that is at least 36" long and extends from the centerline of the toilet at least 12" towards the side wall and at least 24" towards the open side.</p> <p>Ensure side grab bars have adequate clear space.</p> <p>RA: Moderate Impact: High</p>

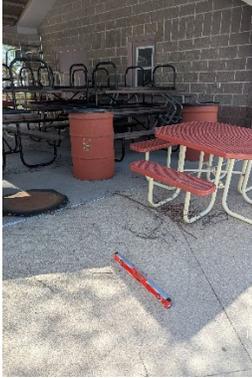
\$3,000	Concessions: No accessible route to concessions / seating areas because grade is too large (14.5% at image). Tables do not allow for wheelchair to utilize with appropriate leg space.	2	Create new path to area at a 1:12 slope or less. Replace 2 tables with ADA adaptable seating. RA: Moderate Impact: Moderate

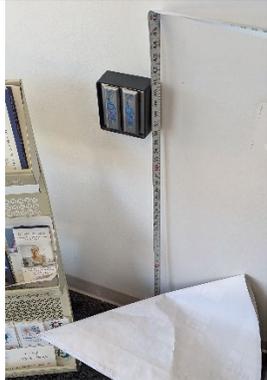
\$500	Main Entrance Doors: Right door closes faster than 5 seconds. (Left door is adequate). ADA operator needs adequate clear space in front of it (30"x48").	1	Adjust or replace closer. Relocate reading material. RA: Easy Impact: Moderate
13-003

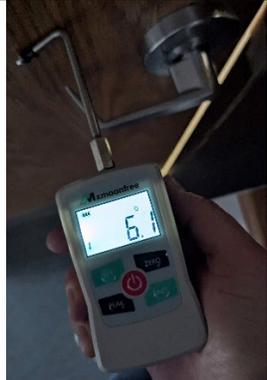
\$500	Restroom Doors: Doors take about 6lbs. of force to open (acceptable = 5lbs.), and close faster than 5 seconds.	3	Adjust or replace closer. RA: Easy Impact: Moderate
13-004

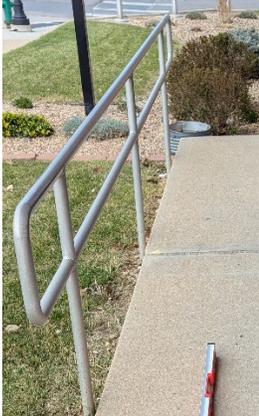
\$3,000	Main Entrance: Handrail does not have slip protection bottom rail and is not located 12" from edge of path.	1	Replace Railing. RA: Easy Impact: High
14-003

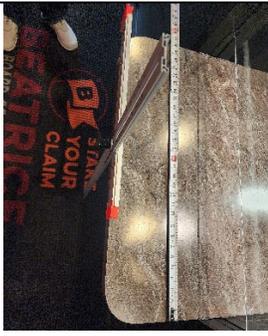
\$1,500	Utility and City Office Counters: Counter space is 30" long (36" min). Counter at 35." Not accessible for employees to use as a work surface, but adequate for public.	1	Lengthen counter to be min 36". RA: Moderate Impact: Low

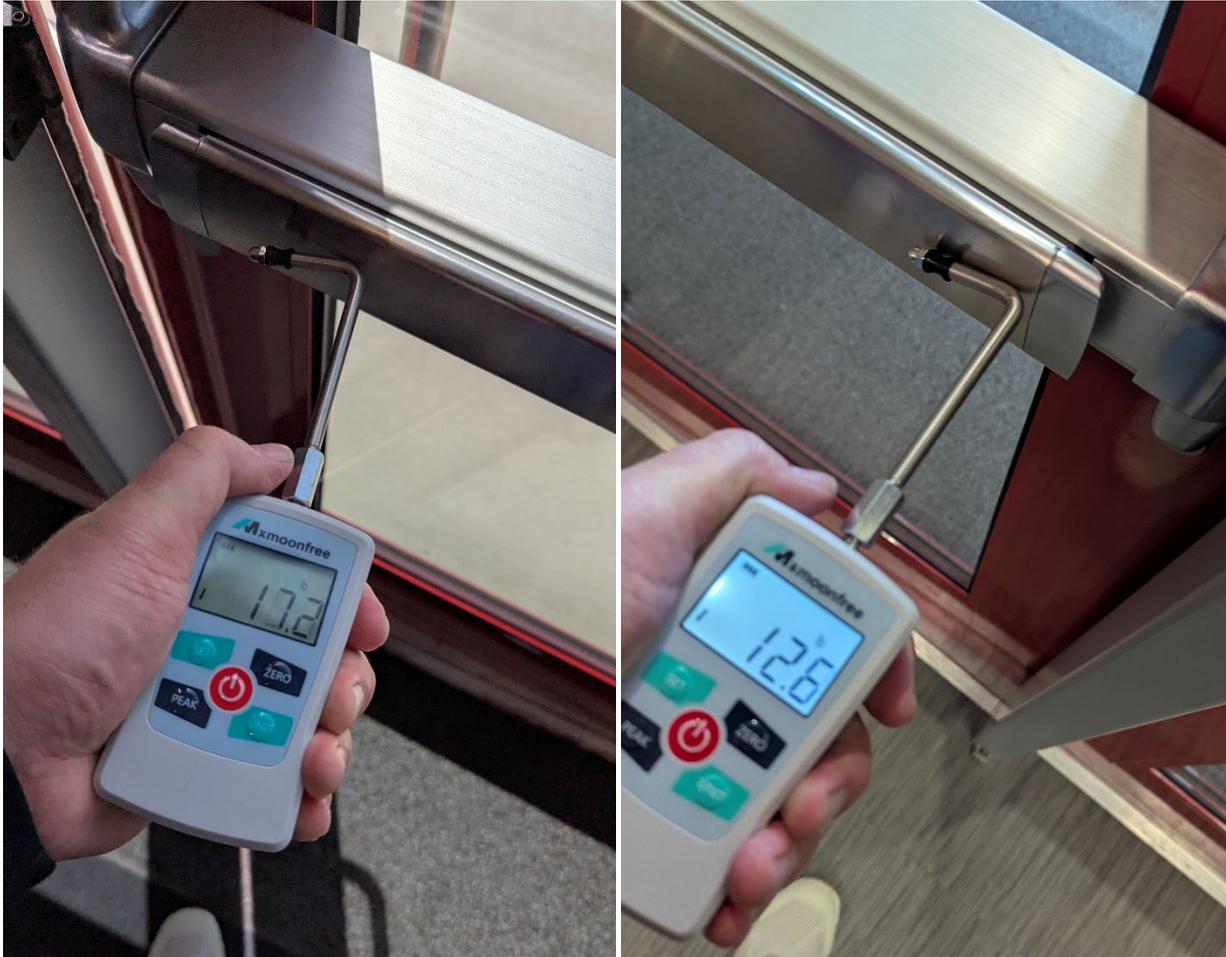
Many areas of the Beatrice Fire Station are not available to the public. The structural evaluation focused on the front door and vestibule space leading into the facility. Each door requires more force to open than what the ADA guidelines suggest and are not considered accessible. Pedestrian access routes surrounding the fire station were also evaluated below.

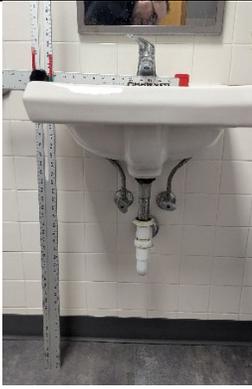
\$120	Restroom: Supply and waste are not insulated. Bottom of reflective surface of mirror is at 42" above the floor.	3	Insulate supply and waste lines and handles. Remount mirror so reflective surface is at 40" or less. RA: Easy Impact: Moderate/Low
16-008

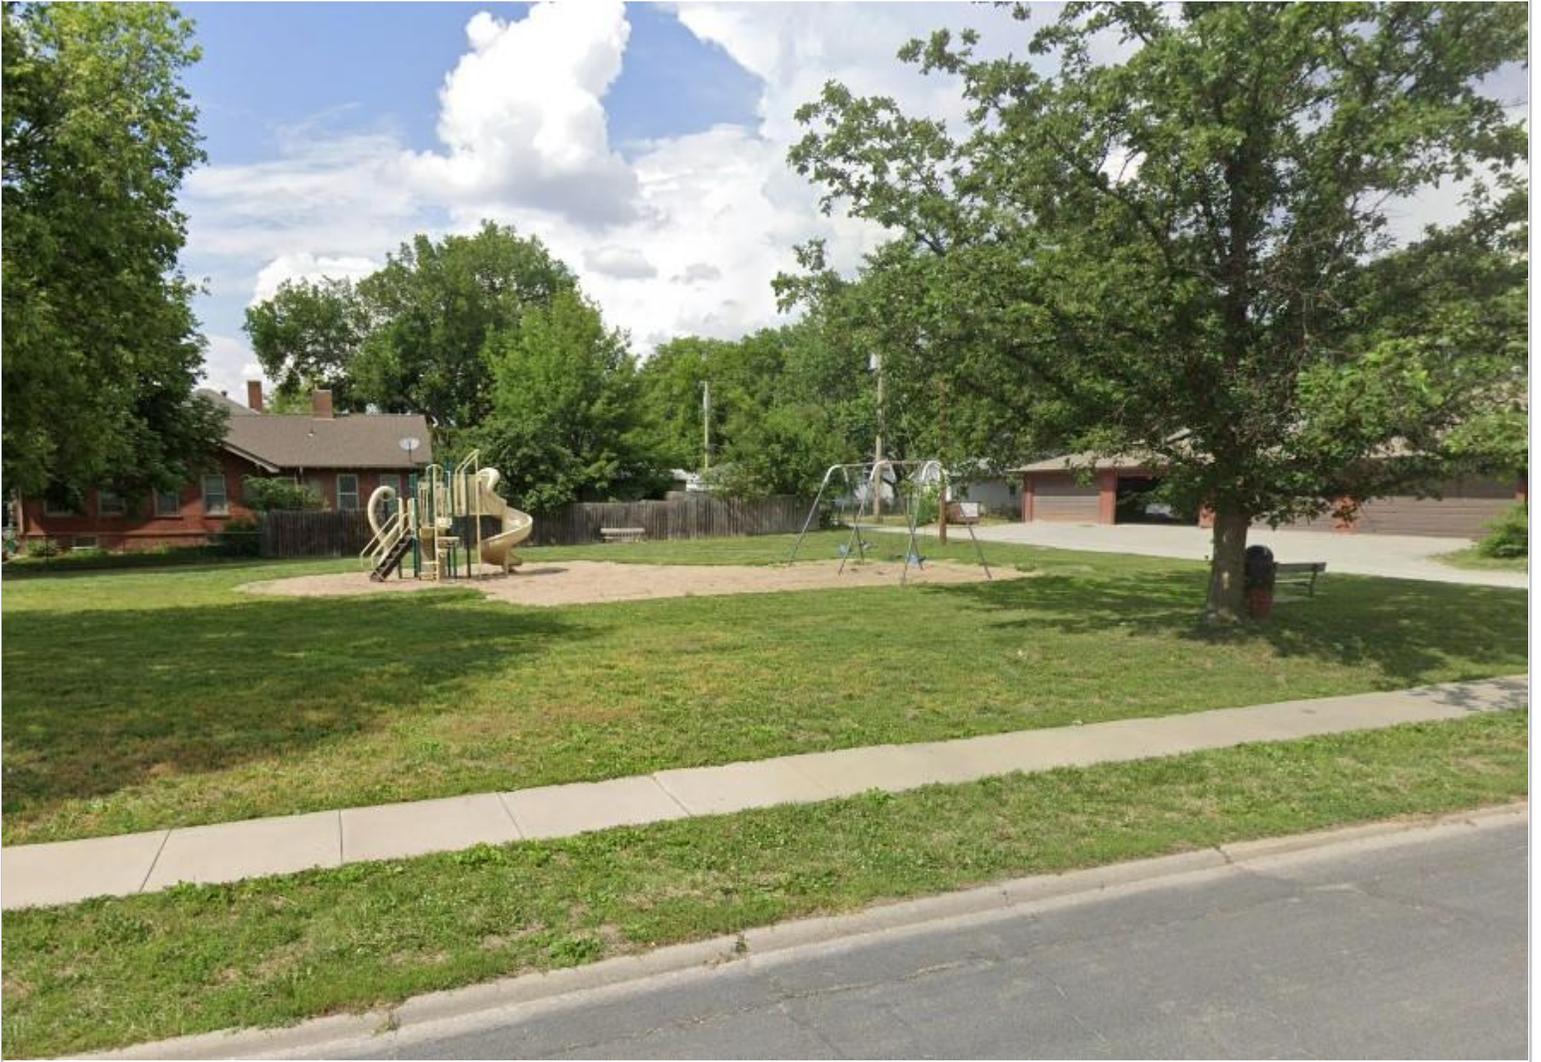
Robertson Park

There is no sidewalk leading to the playground structure so there is no accessible entrance.

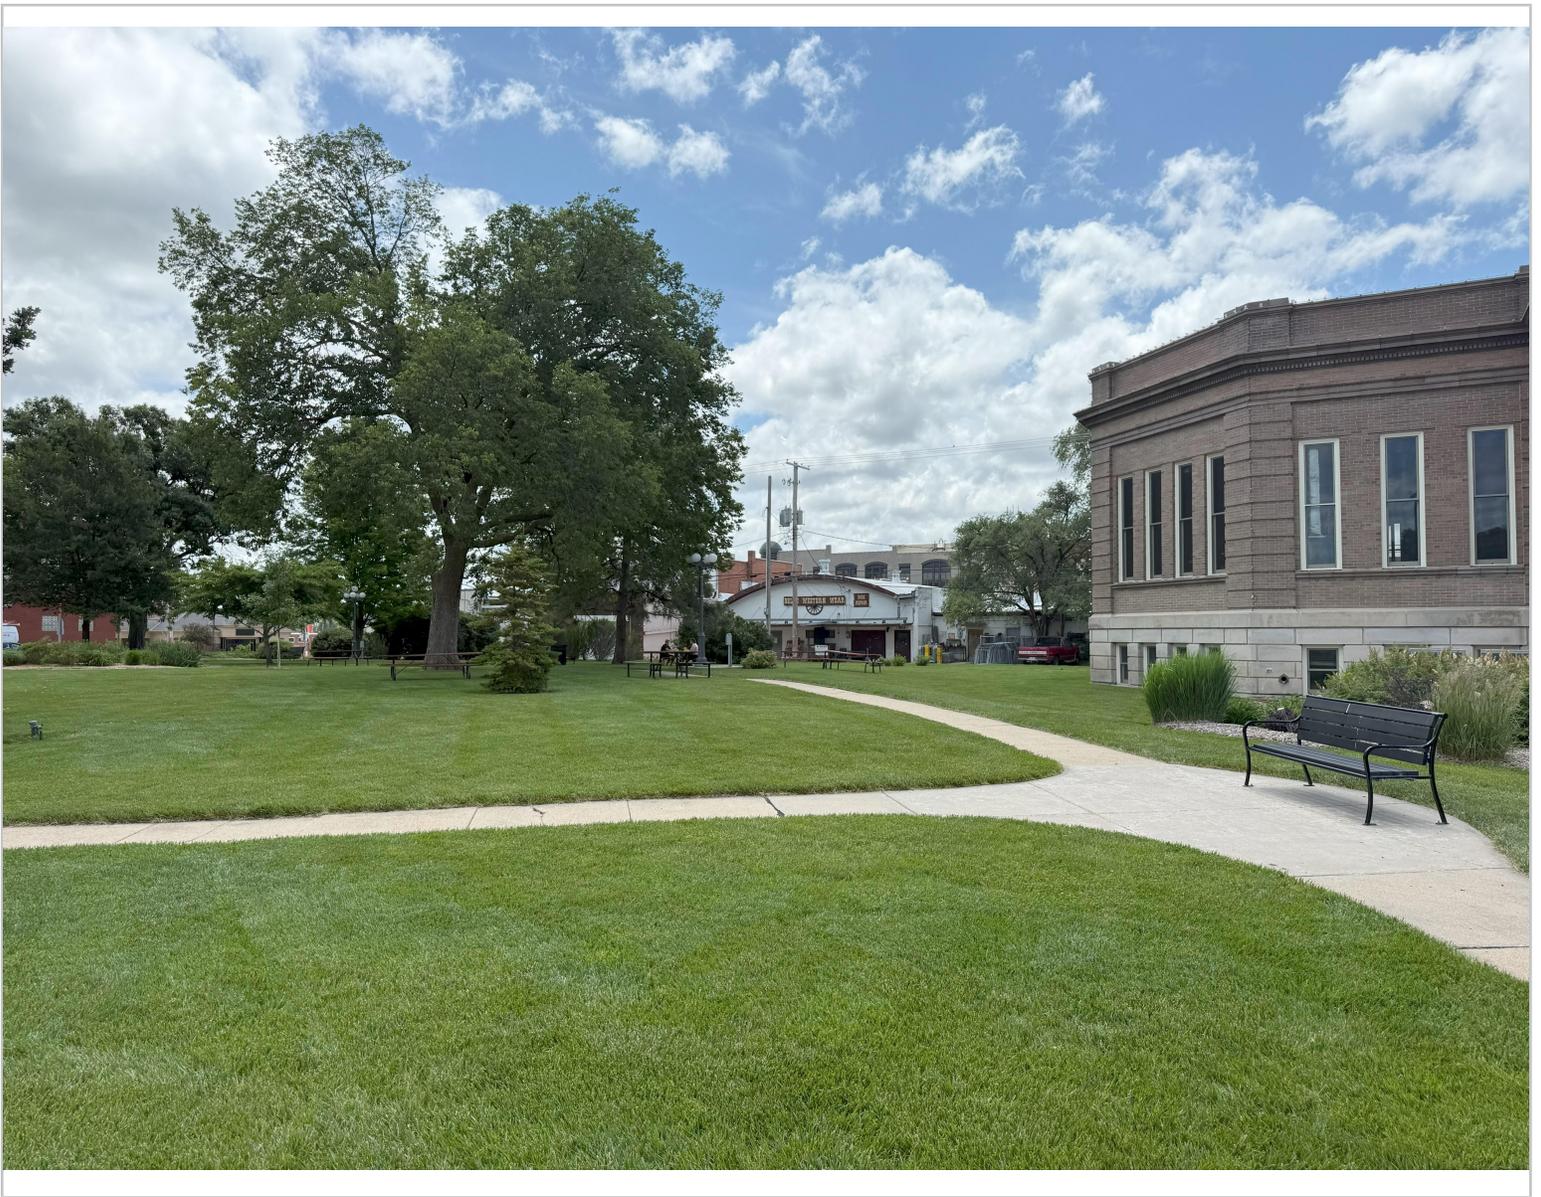
Charles Park

There are benches located on the walking paths and they are accessible.

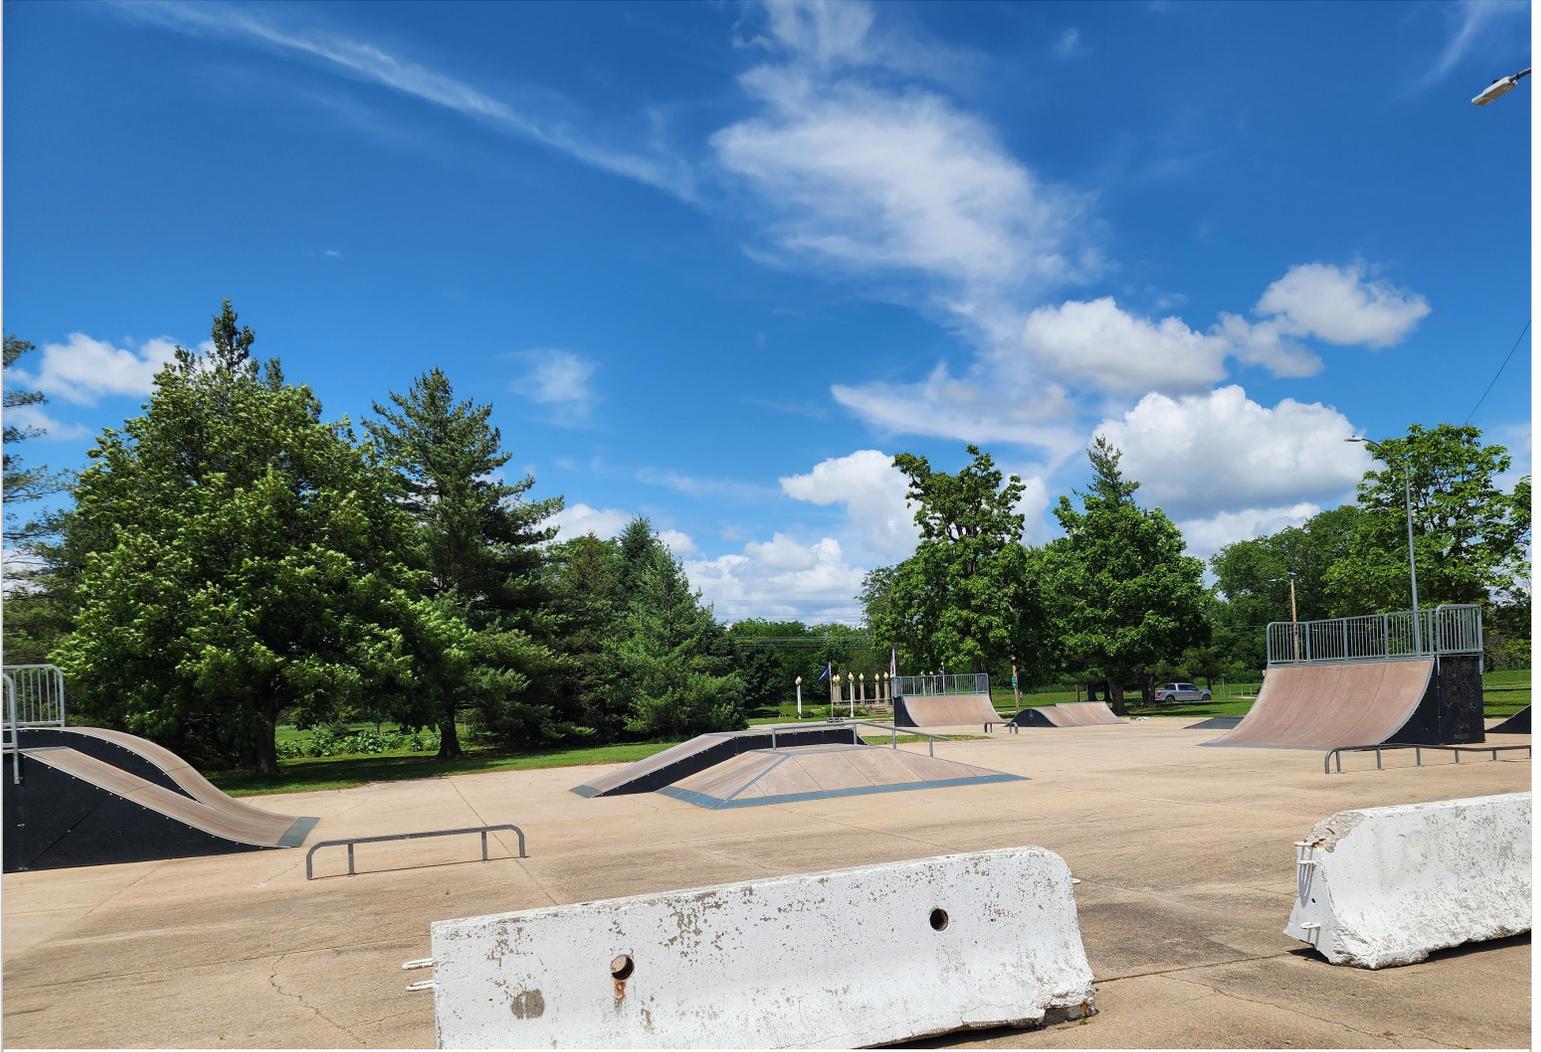
Beatrice Skate Park

Other than the skating equipment, there is also a shade structure. The shade structure has no accessible path leading to it so it is not accessible.

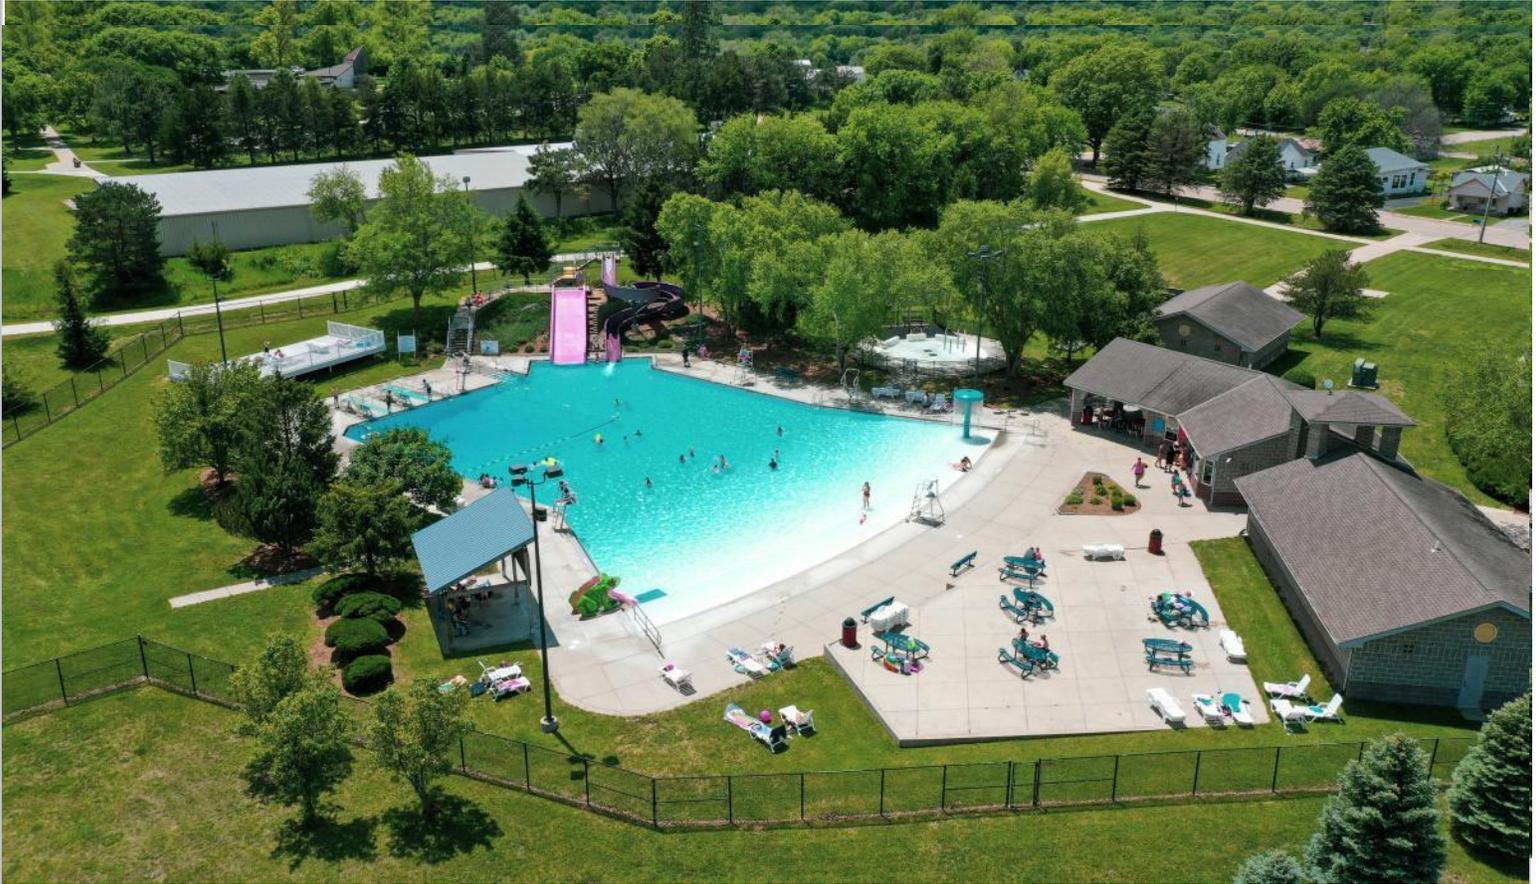
Big Blue Waterpark

Pool Deck Accessibility Summary Path to Raised Deck: 5.4% Concessions: 8.5%, 14.6%, 8.8% Pool Entry: 9.4% Baby Pool: 7.4%

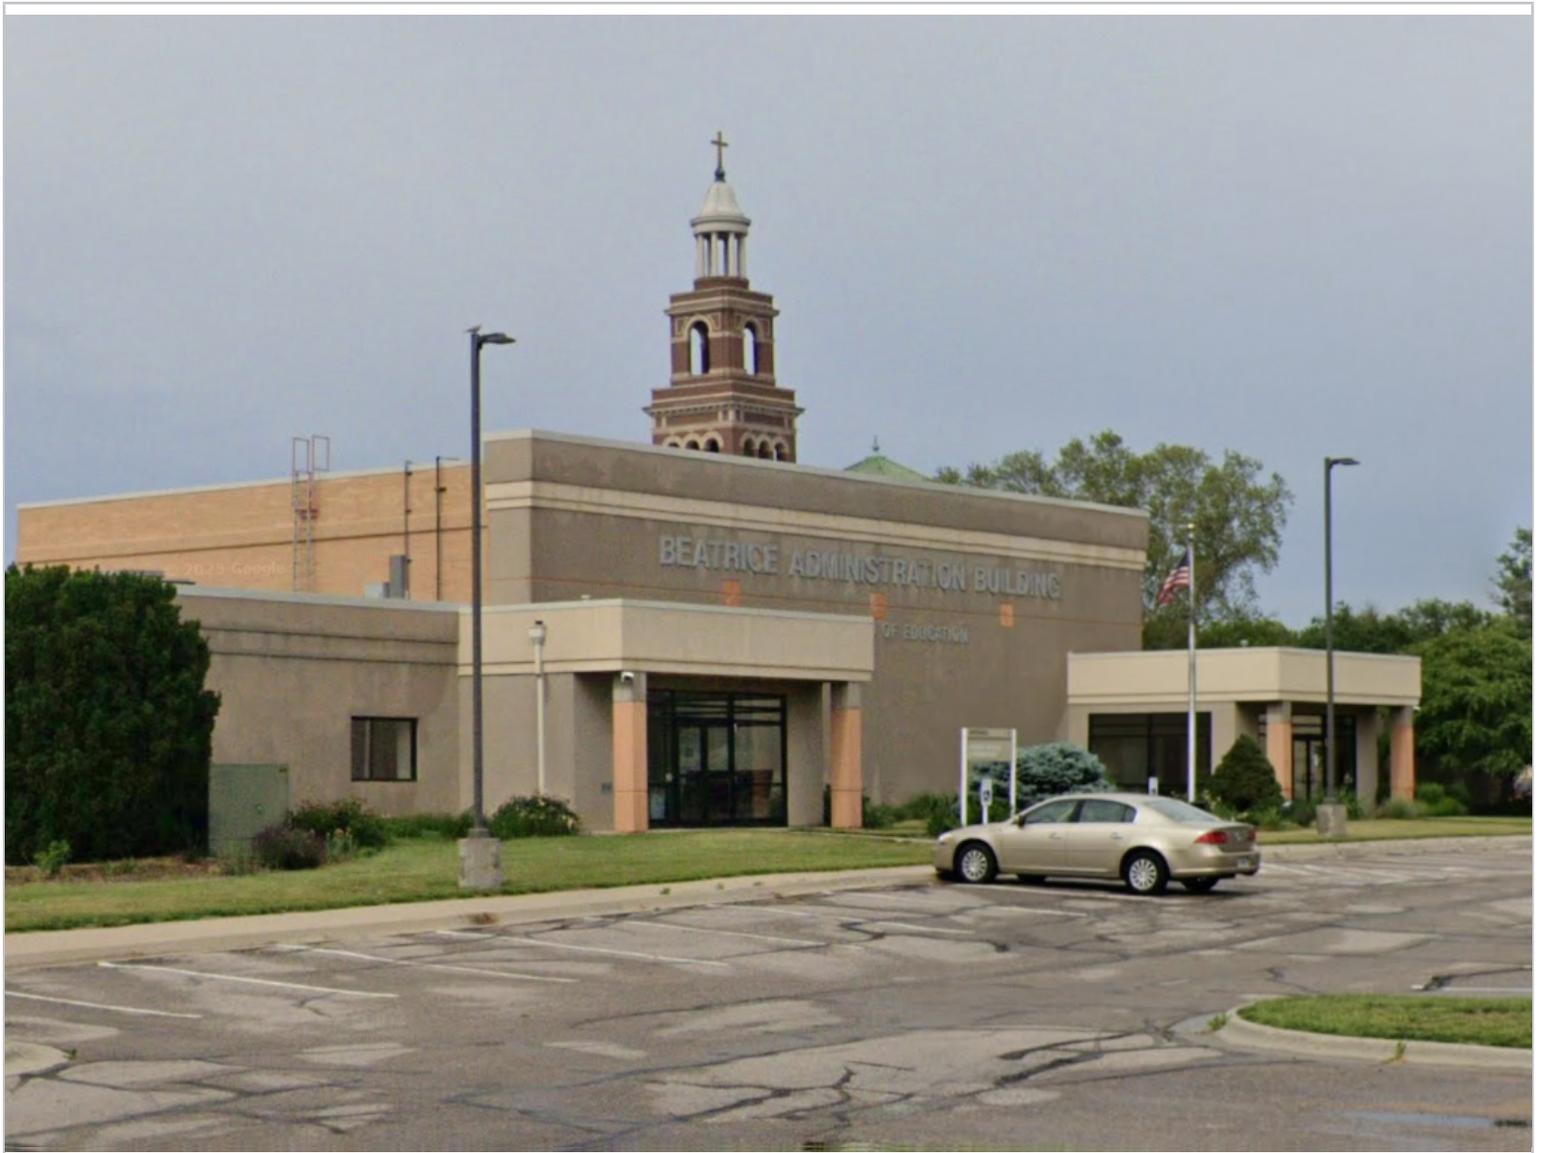
BPS District Office

Ramp leading to board room table has slope of 9.7%.
